GREAT EAST LAKE DAM

NH 00111

PHASE I INSPECTION REPORT NATIONAL DAM INSPECTION PROGRAM

JANUARY 1979

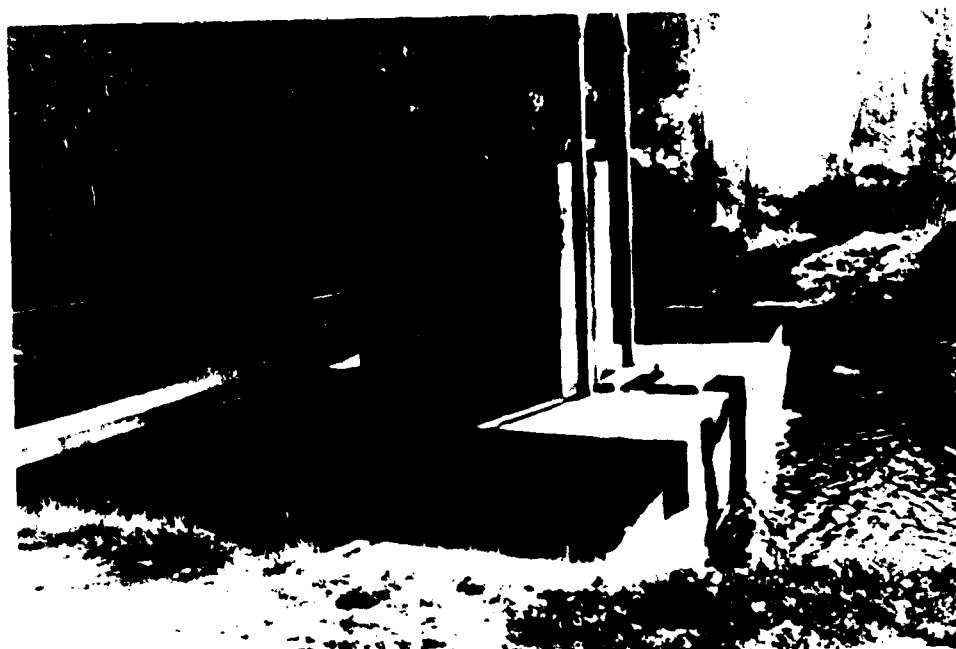
The service deck over the left spillway section and outlet works consists of a concrete deck, tube railing and concrete supports. The deck and the supports are in very good condition as shown in Photo 4.

PHOTO NO. 4 - View of dam from left abutment (upstream side).

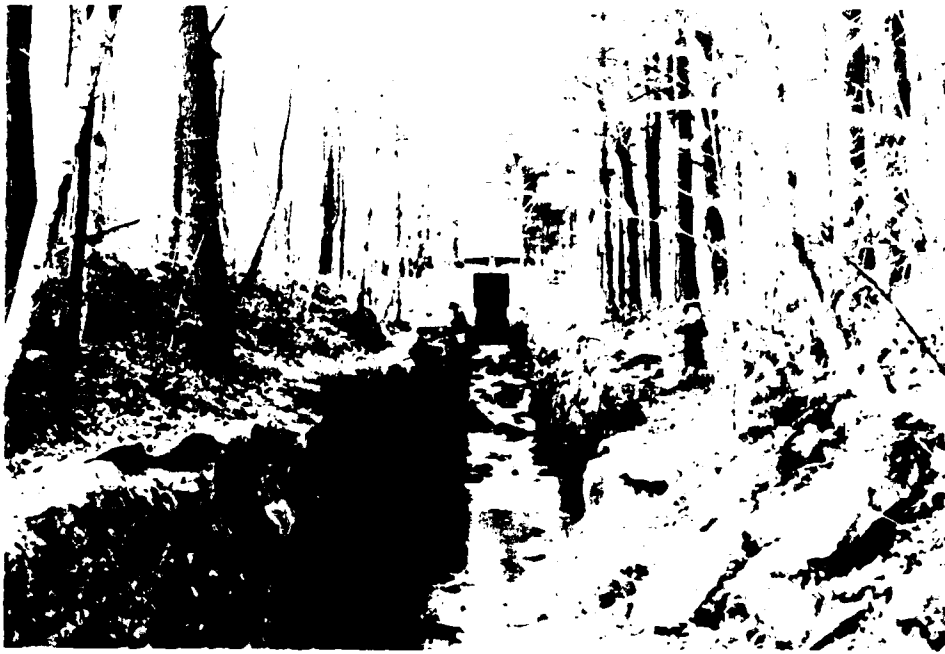
Minor bulging and misalignment of the vertical, dry-masonry walls on the sides of the discharge channel downstream of the dam indicate that the stability of those walls is deteriorating with time, and that they will need to be repaired from time to time as part of the routine maintenance program.

PHOTO NO. 11 - View of discharge channel, looking upstream.

(a) Inspect the condition of the vertical, dry-masonry walls on the sides of the discharge channel from the dam to Canal Road at least once a year and make repairs when needed.

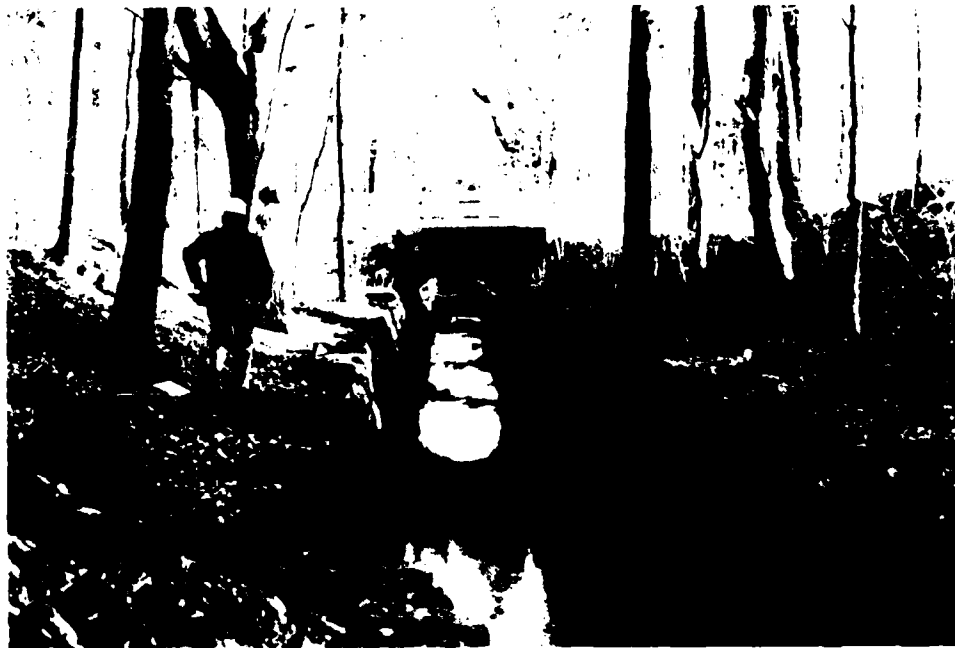
PHOTO NO. 12 - View of discharge channel,
looking downstream.
